**NATIONAL TRANSPORTATION SAFETY BOARD
Office of Research and Engineering
Vehicle Recorder Division
Washington, D.C. 20594**

GROUP CHAIRMAN'S FACTUAL REPORT OF INVESTIGATION

DCA18MM028

Group Chairman's Factual Report By Sean Payne

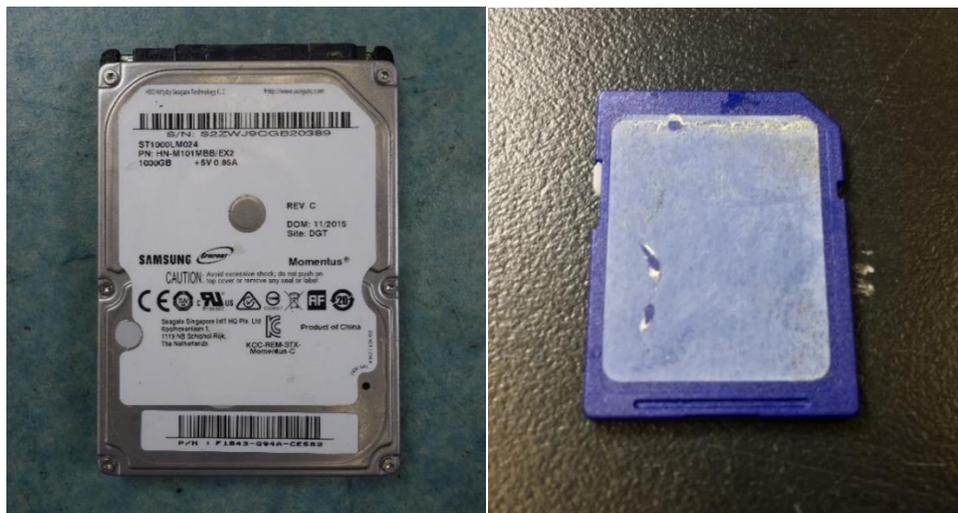
Figure 1. The HDD and SD card associated with the MDR (SN: 1603MCU80040) from SD7. The HDD has been removed from the MDR enclosure in this photograph (left).

The HDD from SD7 showed signs of water exposure and slight corrosion damage. The HDD was rinsed in filtered water in the Vehicle Recorder Laboratory and evaluated. The damage to the HDD required repair within a clean room facility. The HDD was later provided to an assisting federal agency with a clean room facility. The assisting federal agency attempted to repair the HDD, but was unsuccessful. No data was recovered from the HDD associated with SD7.

The SD card associated with the MDR on SD7 was rinsed and dried in the Vehicle Recorder Laboratory using a vacuum drying oven. The SD card was read out using the manufacturer's software and suggested procedures, normally and without difficulty. The results of the recovery are described later in this report.

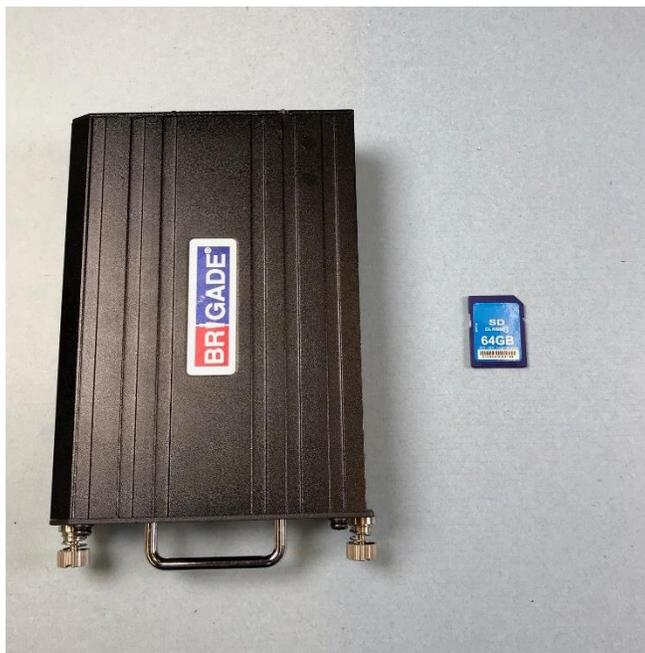
The HDD and SD card associated had already been handled on scene by parties other than the NTSB prior to the team's arrival in Branson on July 21, 2018. The HDD and SD were transferred to the custody of the NTSB's General Council on-scene representative on July 23, 2018. The devices were read on-scene via a PC using the manufacturer's software, normally and without difficulty by an NTSB recorder specialist. The HDD and SD card were hand carried to the NTSB Vehicle Recorder Laboratory and logged into evidence on July 28, 2018. The devices are shown below in figure 2.

Figure 2. The HDD and SD card associated with the MDR (SN: 1508MCU80013) from the SD54.

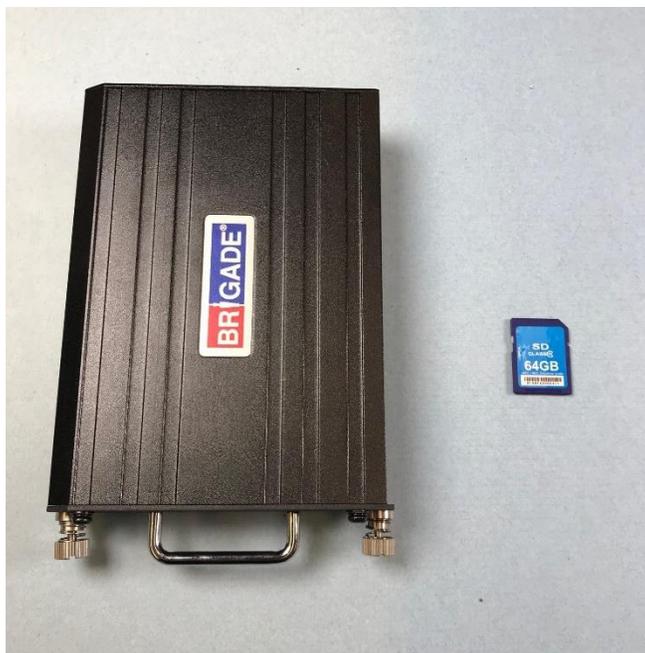
The HDD and SD card associated with SD17 was transferred to the custody of the NTSB's General Counsel on-scene representative on July 23, 2018. The devices were read on-scene via a PC using the manufacturer's software, normally and without difficulty by an NTSB recorder specialist. The HDD and SD card were hand carried to the NTSB Vehicle Recorder Laboratory and logged into evidence on July 28, 2018. The devices are shown below in figure 3.

Figure 3. The HDD and SD card associated with the MDR (SN: 1508MCU80034) from the SD17.

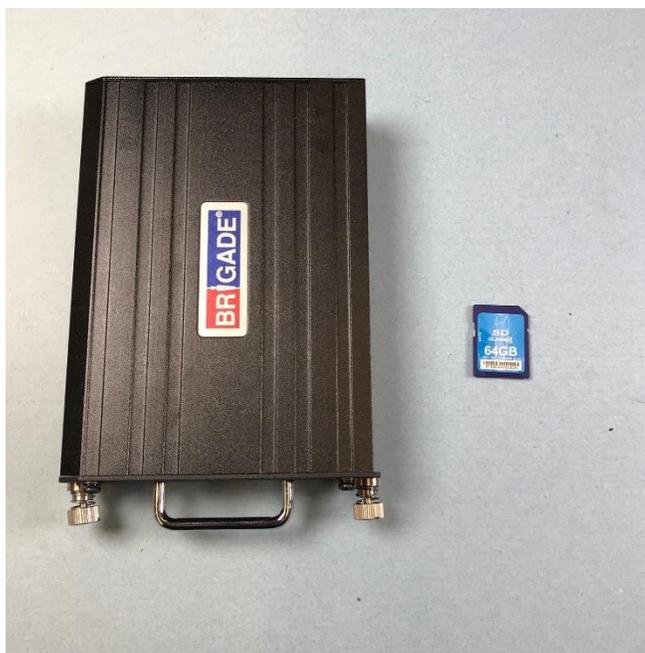
The HDD and SD card associated with SD27 was transferred to the custody of the NTSB's General Counsel on-scene representative on July 23, 2018. The device's were read on-scene via a PC using the manufacturer's software, normally and without difficulty by an NTSB recorder specialist. The HDD and SD card were hand carried to the NTSB Vehicle Recorder Laboratory and logged into evidence on July 28, 2018. The devices are shown below in figure 4.

Figure 4. The HDD and SD card associated with the MDR (SN: 1508MCU80050) from the SD27.

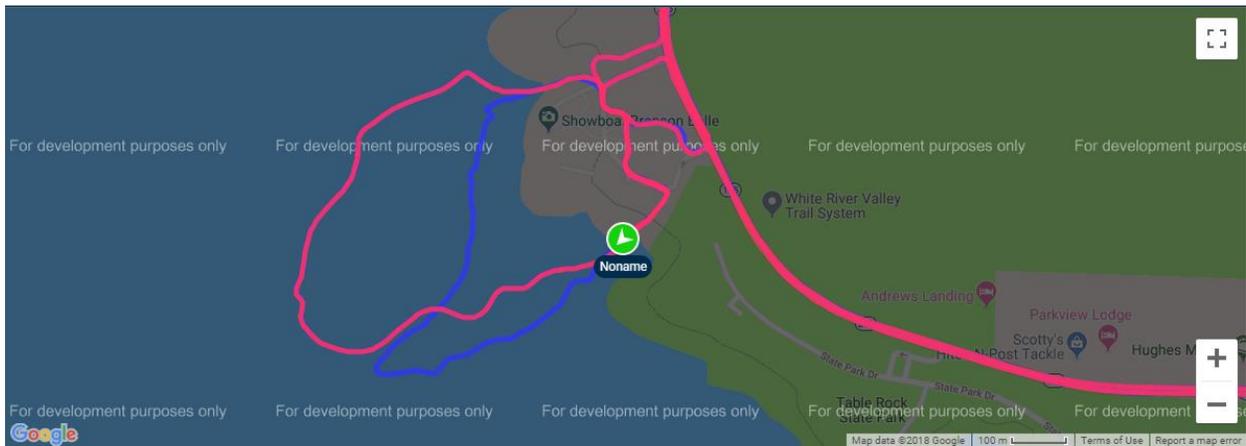
Figure 6. Parametric data showing the vessel's path from SD54.

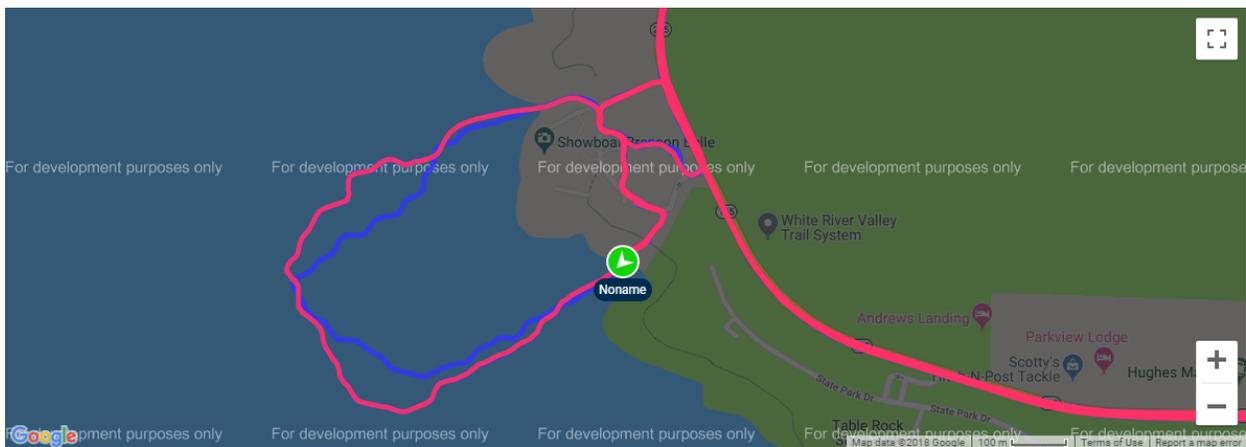
Figure 7. Parametric data showing the vessel's path from SD17.

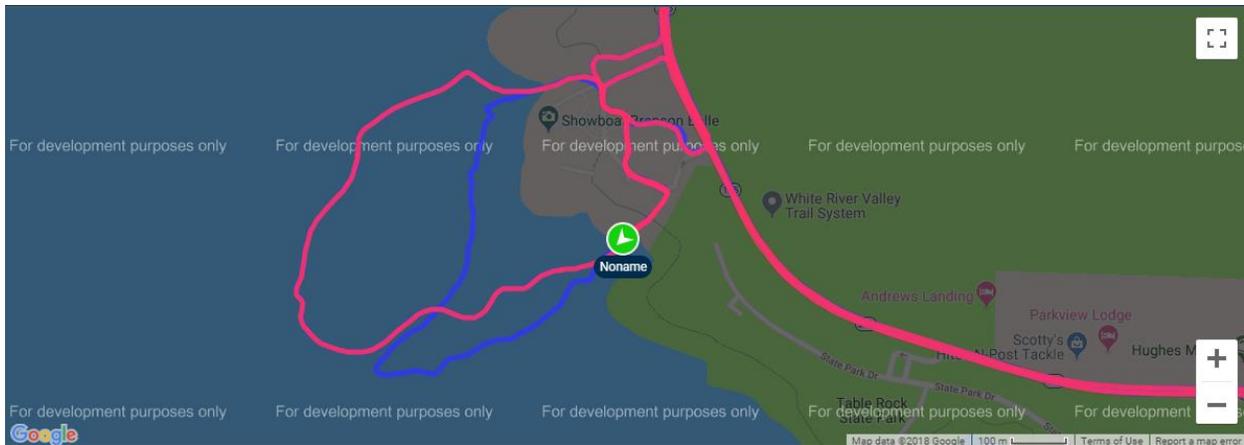
Figure 8. Parametric data showing the vessel's path from SD27.
