NATIONAL TRANSPORTATION SAFETY BOARD
Office of Research and Engineering
Washington, D.C. 20594

Video Study

**NTSB Case Number:
DCA18MM028**

Location: Branson, Missouri
Date: July 19, 2018
Time: 7:08 PM CDT
Vessel: Stretch Duck 7 (SD7)

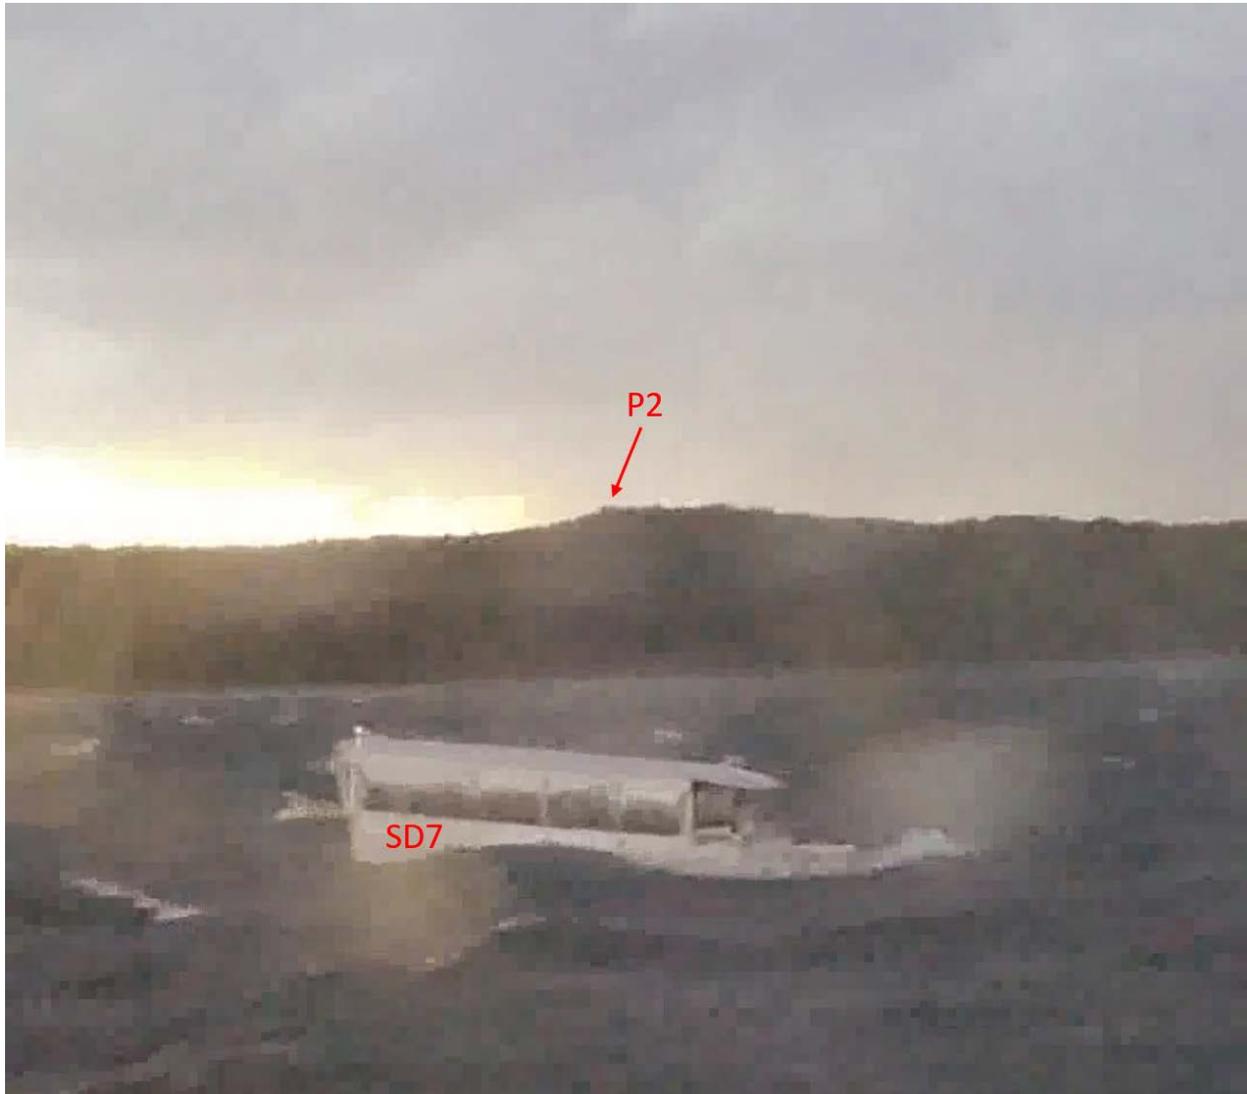
Figure 5. Upper Half of a Frame from the Showboat Video Showing P2 and SD7

Figure 5 shows the upper half of a frame from the Showboat video. It displays terrain peak P2 and also shows SD7. Because the video was recorded in the evening and during a storm, only the outline of the terrain across the lake can be seen. This is the reason for using the pitch angle to terrain, shown in Figure 4, for correlating Showboat video frames with the terrain elevation data during the camera calibration process and during SD7 location estimation described below.

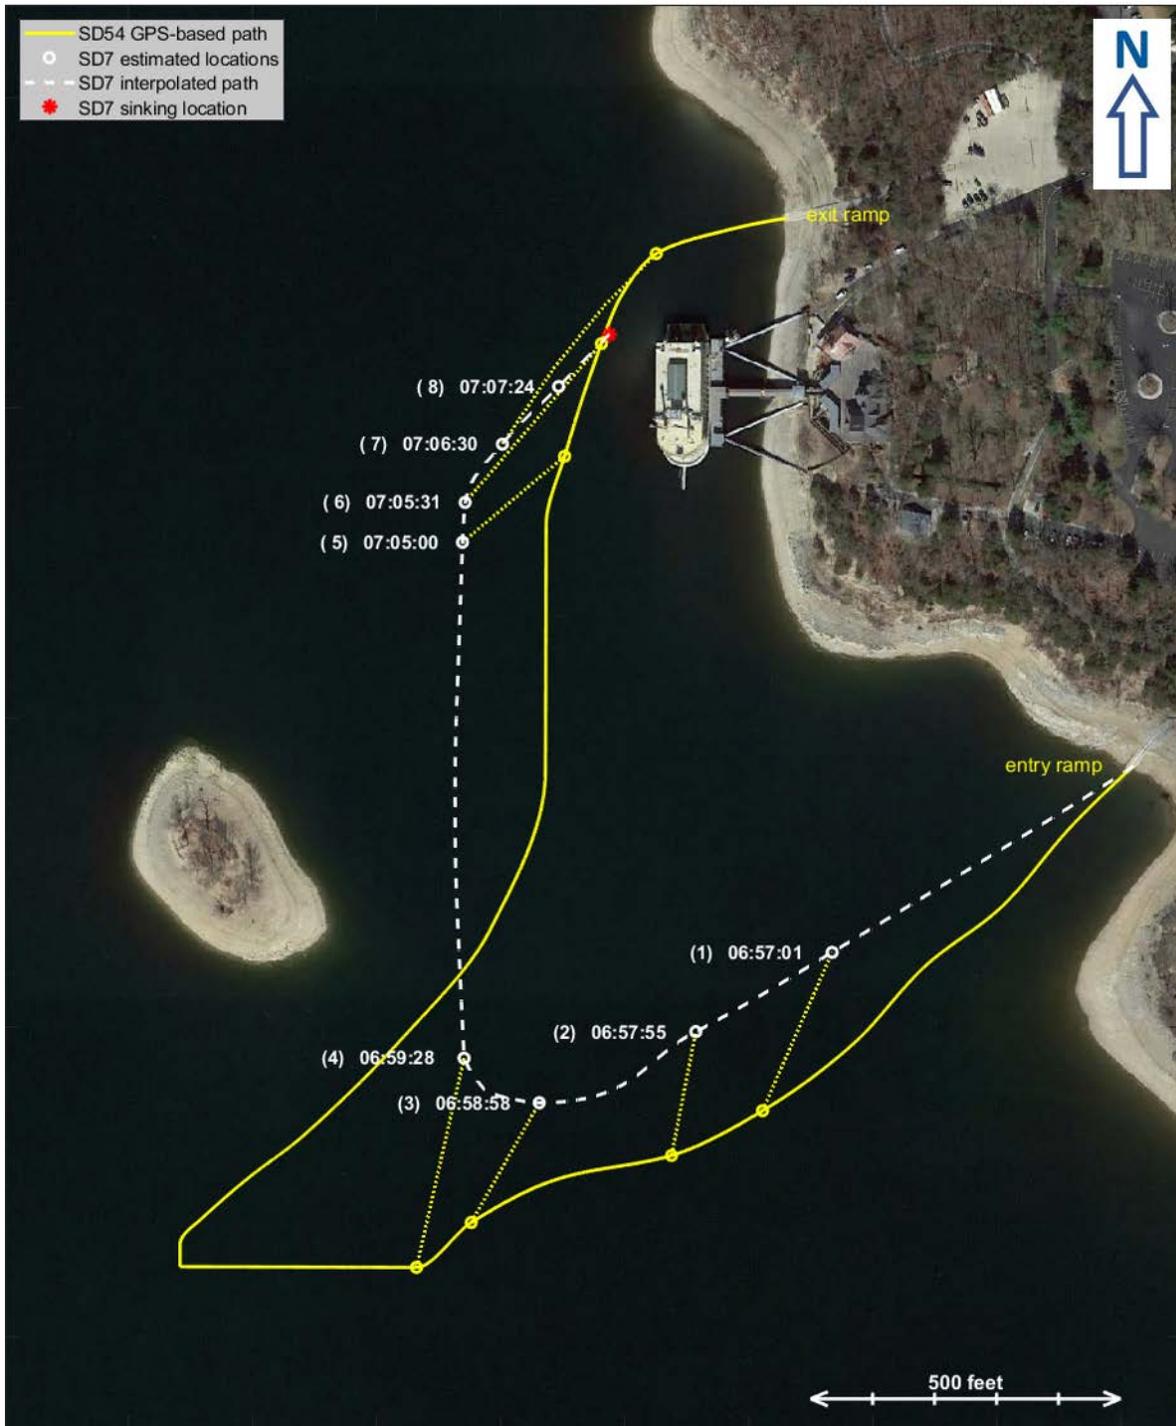
Figure 7. Aerial View of the Accident Area with Marked SD54 and SD7 Paths

This analysis step was performed four times, resulting in four SD7 location estimates. They are marked by the white circles in Figure 7. The four locations are numbered 1 through 4 and the times when SD7 was at these locations, known from the GPS-based time stamps on the SD54 video frames, are shown next to the point numbers. The dotted yellow lines connect points 1 through 4 with points on the path of SD54. These are the SD54 path locations where SD54 was when the corresponding SD7 locations were estimated.

Four SD7 locations were estimated based on the Showboat video. They are marked by the white circles numbered 5 through 8 in Figure 7. The times corresponding to points 1 through 4 in the figure were based on the GPS-based time stamps on the SD54 video frames. The Showboat video frames did not have time stamps but its frame rate was known to be 30 fps. Showboat video frames that displayed SD7, SD54 or both were used for correlating the frame times in the Showboat video with the GPS time stamps of the SD54 video. The estimated accuracy of this time alignment was ± 5 seconds. This time alignment made it possible to assign accurate GPS times to the four SD7 locations that were based on the Showboat video. These times, corresponding to points 5 through 8, are displayed in Figure 7.

The dotted yellow lines in Figure 7 that originate at points 5, 6 and 7 connect these points with the locations on the path of SD54 where SD54 was at the times when SD7 was at 5, 6 and 7. When SD7 was at location point 8, SD54 was already out of the lake.

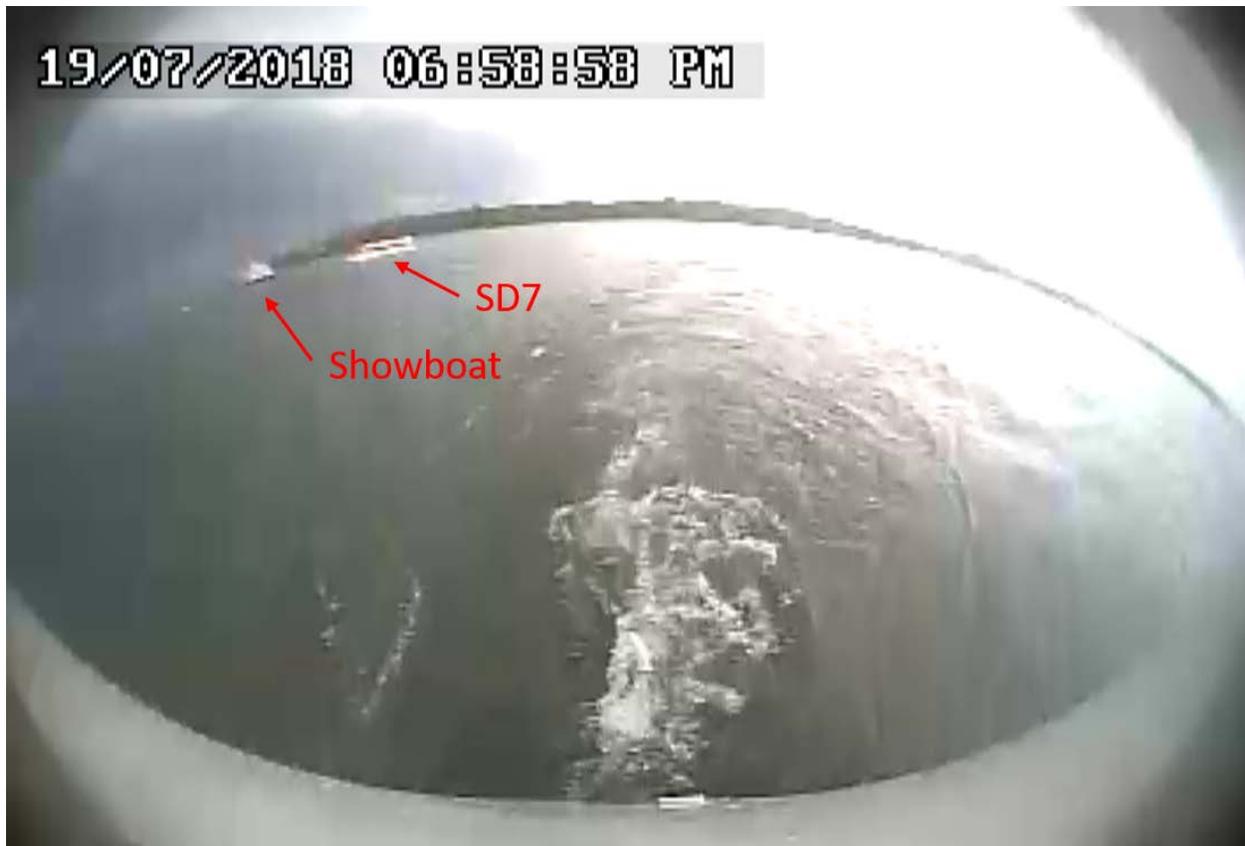
Figure 8. Frame from the SD54 Video Showing SD7 at Time 06:58:58

Stretch Duck SD54 entered the lake at 06:53:42. Stretch Duck SD7 entered the lake at 06:55:37, 115 seconds after SD54 entered. The SD54 rear-facing camera recorded SD7 from the time it entered the lake. Between time 06:57:01 and time 06:59:28, the image of SD7 in the video was sufficiently clear to allow estimation of SD7 locations. Figure 8 shows SD7 in a video frame recorded at time 06:58:58. Note the barrel distortion caused by the wide-angle camera lens, as was the case during camera calibration (see Figure 1). The distortion was mathematically corrected before analyzing the video frame.

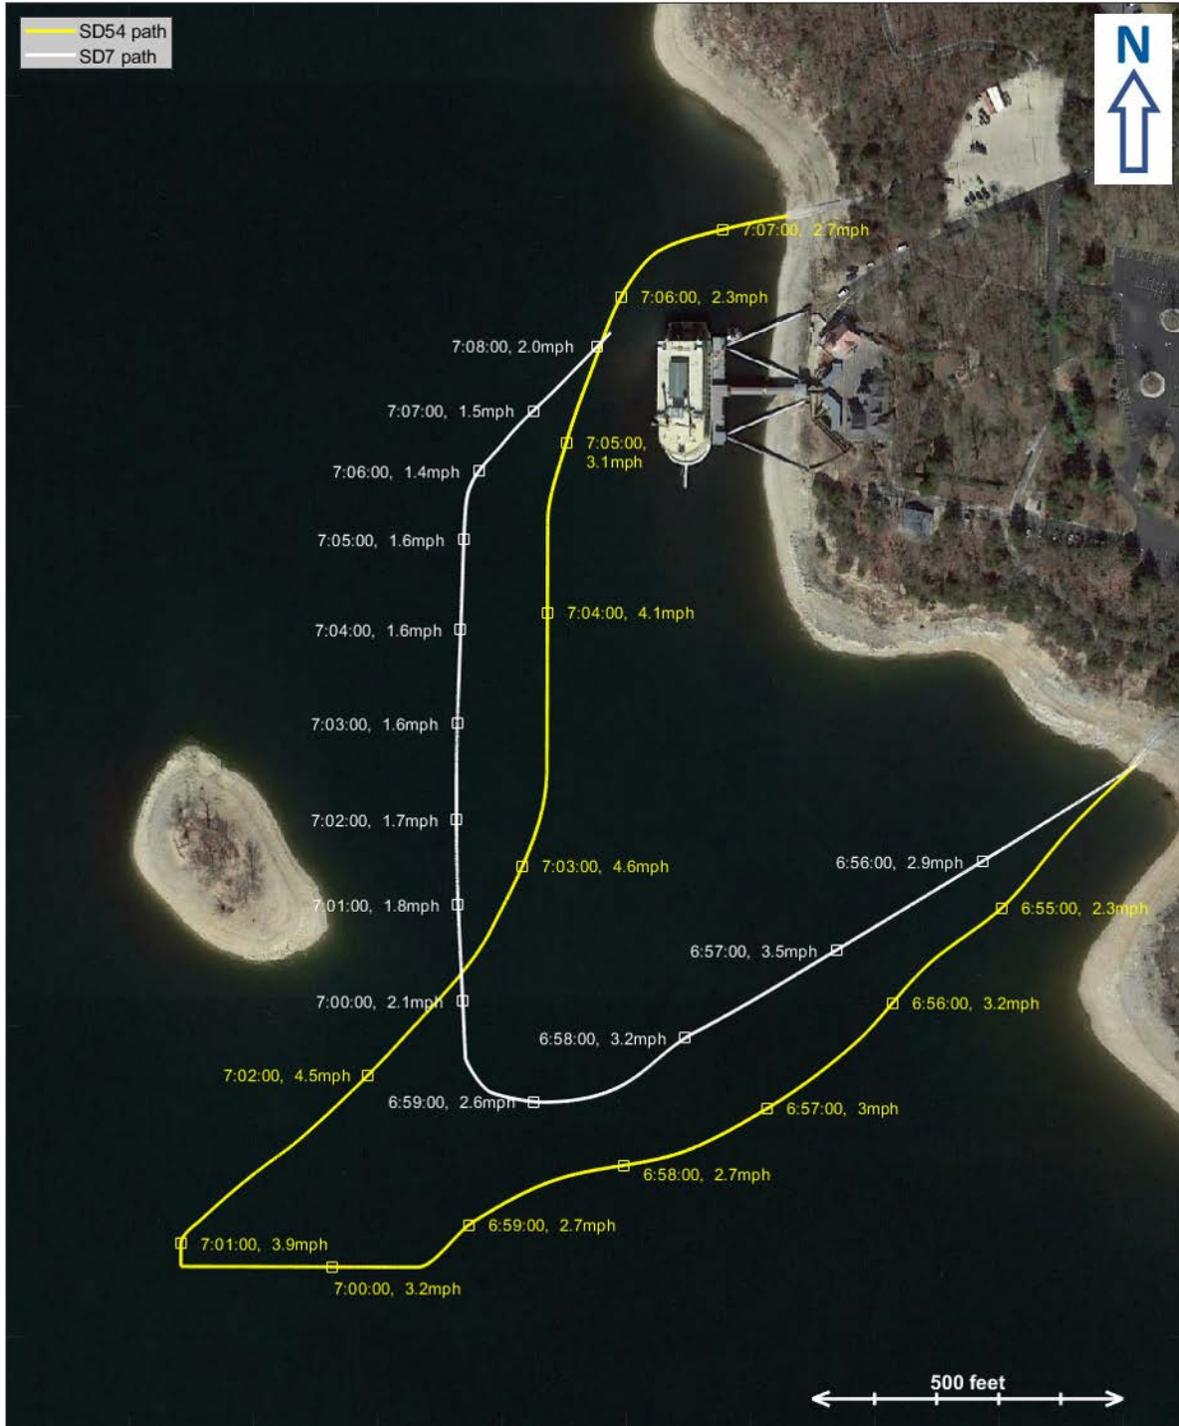
Figure 9. Locations and Speeds of SD54 and SD7 along their Paths

Figure 9 shows that until time 6:59:00, both boats moved southwest at about 3 mph. SD54 turned north, toward the exit ramp, at about time 7:01:00. It was already increasing its speed when it turned. Its speed peaked at 4.6 mph at time 7:03:00.

SD7 started turning north, toward the exit ramp, at about time 6:59:00. Its average speed decreased to about 1.7 mph after the turn. Consequently, while it turned north about two seconds before SD54 did, at time 7:04:00 SD54 was already ahead of it on its way toward the exit ramp because it moved faster. When SD7 sank, at about 7:08:00, SD54 was already out of the lake.

There is no direct information in the two analyzed videos to explain why the speed of SD7 was so much lower than the speed of SD54. One possible reason is the path SD7 took toward the exit ramp. As can be seen in Figure 9, SD7 path was almost 200 feet west of the path of SD54 and, therefore, farther away from the shore. It is possible that winds, waves and currents caused by the storm were stronger farther from the shore and slowed SD7 as it attempted to reach the exit ramp.

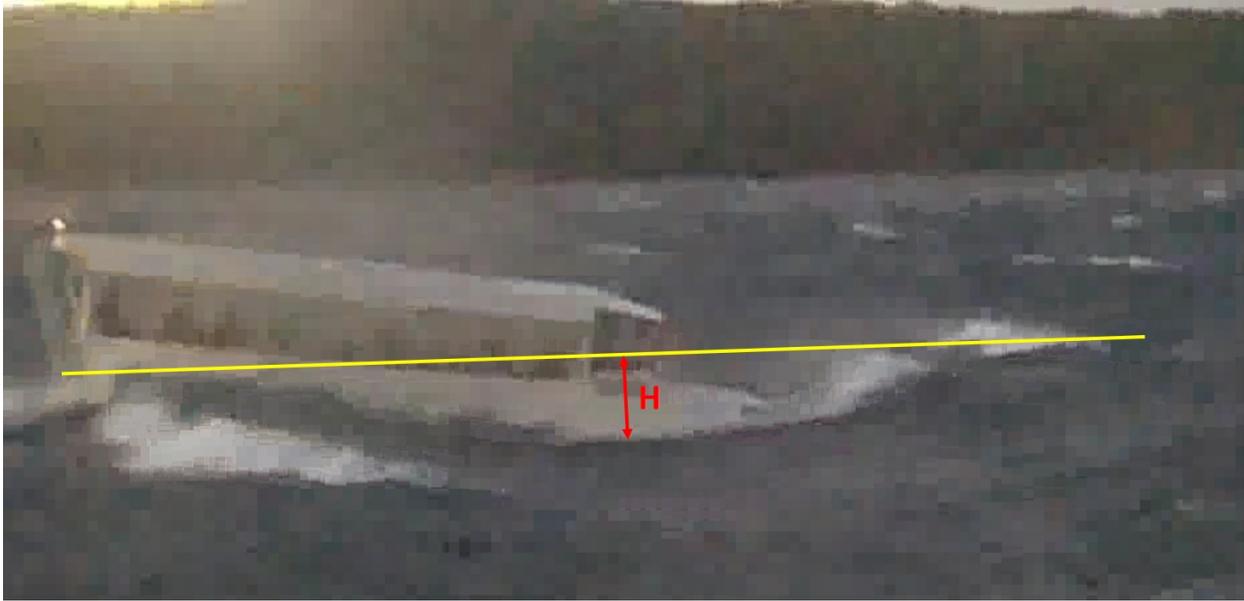
Figure 10. Wave Height Estimation

Figure 10 illustrates the wave height estimation method. A video frame was selected where a vessel and two wave crests were visible. A line, shown in yellow in the figure, was drawn that was tangential to both crests. The distance H from the yellow line to the trough between the crests, measured perpendicularly to the yellow line, was considered an estimate of the wave height. Figure 10 shows SD7 and the highest wave that was observed in the Showboat video. The estimated wave height H was 3.5 feet.

The video frame in Figure 10 and other frames show waves with wavelength of about 40 feet, a length that is close to the 33-foot length of the vessel. This resulted in large pitch motions of the vessels, as large as 6° at times. The estimated frequency of the pitch motion of the vessels was about 0.4 cycles/second. The large pitch angles resulted in the bow of the vessel going occasionally under water when a wave was approaching a vessel oriented with a bow-down pitch angle, as seen in Figure 10.

Vessel SD7, seen in Figure 10, was moving forward at about 1.6 mph. The waves were approaching the bow of the vessel (moving right to left in the figure) at the speed of about 10 mph at that time, slowing the forward motion of the vessel.
